The Peninsula's Community College

Municipal Separate Storm Sewer System Annual Report

Reporting Period: July 1, 2020 to June 30, 2021

General Permit No. VAR040087

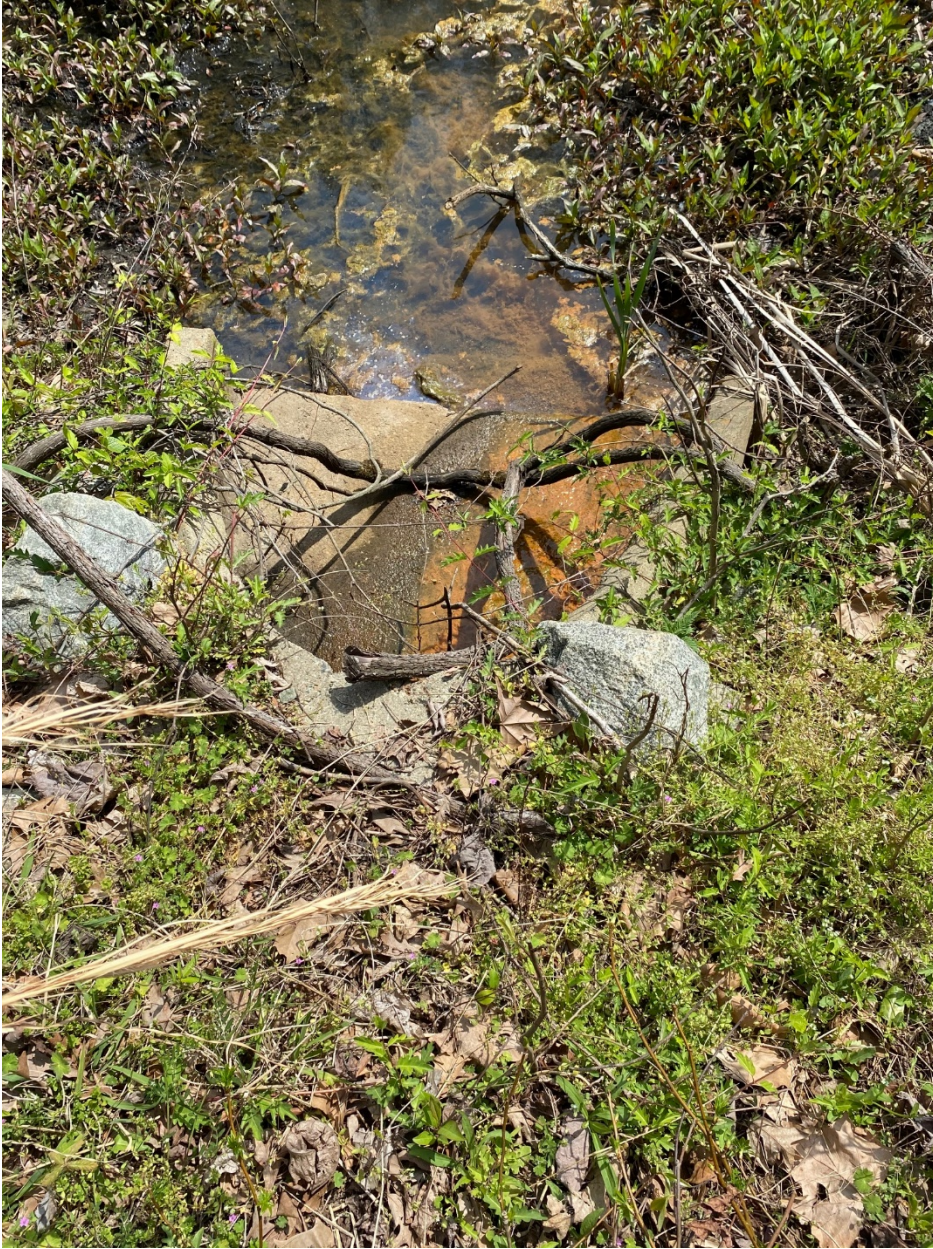
Photo #OF-G-1. In flat area of pipe end section – accumulated orange deposits/stains similar to pavement staining color near dumpster.

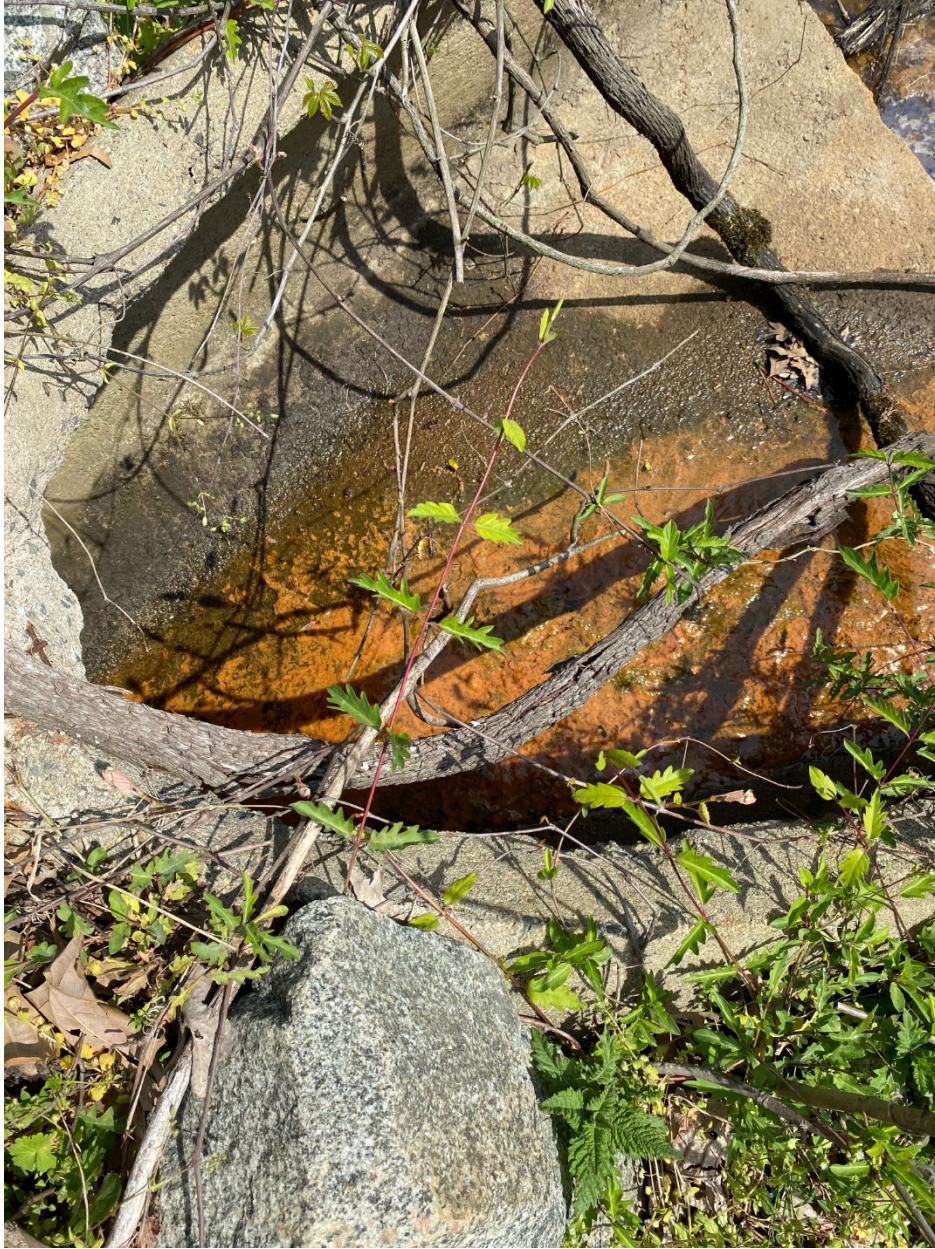
Photo #OF-G-2. In flat area of pipe end section – accumulated orange deposits/stains similar to pavement staining color near dumpster.

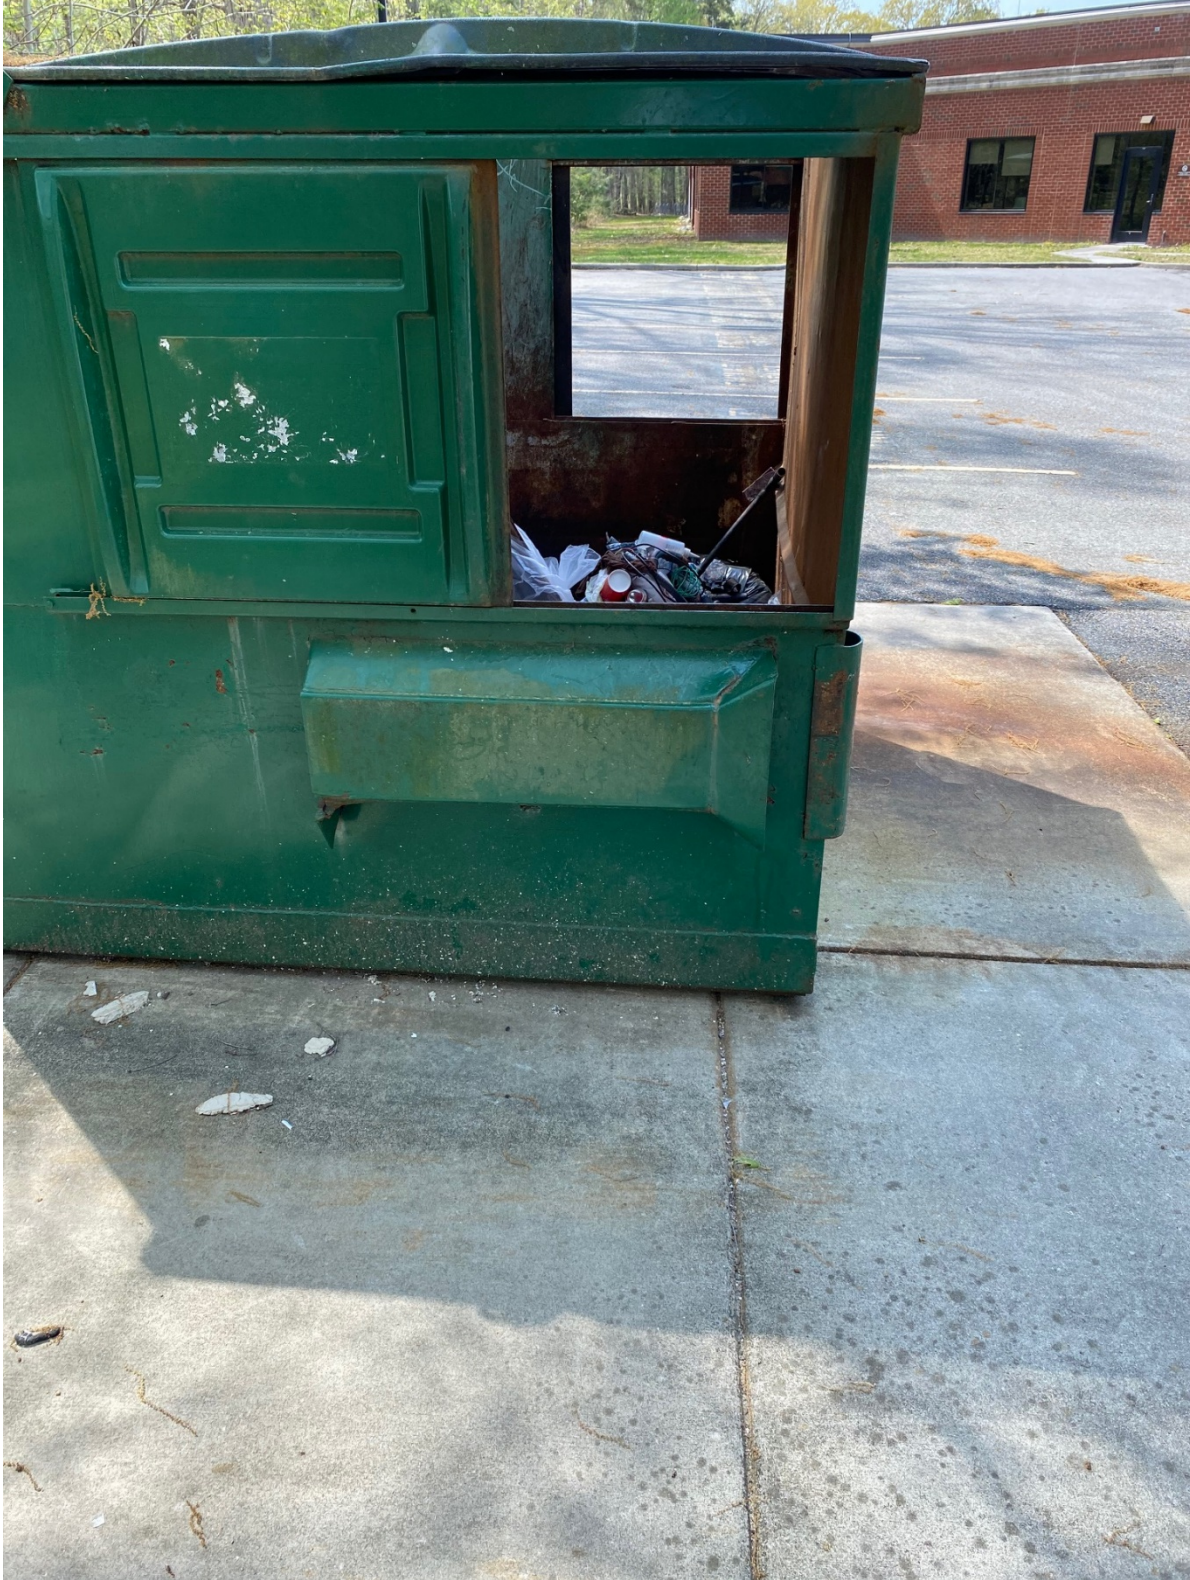
Photo #OF-G-3. Staining apparent on pavement all the way to receiving inlet (see also 2019-2020 report for this outfall). Staining indicates leak(s) in the bottom of dumpster. Dumpster also observed to be open, allowing for exposure of contents to stormwater.

Effectiveness Assessment for Addressing Illicit Discharges
Were all instances of identified illicit discharge listed in Appendix A closed?
<i>Yes. One apparent illicit discharge was observed at OF-G near the Hampton III building. The illicit discharge was tracked to a leaky nearby dumpster. TNCC contacted the contractor, Waste Management, to address the issue. The drain cap was replaced and signage has been installed requesting the top be closed after use. The issue was addressed/closed on June 8, 2021. Effectiveness of the remedy will be assessed with future outfall inspections.</i>

Effectiveness of Program to Prevent Illicit Discharges from Campus Operations	
Were there any illicit discharges from BMP 3C reporting that originated from campus operations of maintenance activities?	<input checked="" type="checkbox"/> Yes <input type="checkbox"/> No
Total number of illicit discharges originating from campus operations of maintenance activities:	1
Describe any potential changes to the <i>TNCC Staff Handbook for Good Housekeeping and Pollution Prevention</i> to prevent future occurrences, if applicable. <i>Refer to reporting for BMP 3C regarding the illicit discharge instance. No changes are needed as dumpster operations are addressed in the Handbook. The issue was related to a faulty drain plug.</i>
